**Madame John's Legacy**  
**Pilot Project to Develop a Treatment Protocol**  
**for Salt Damaged Brick Masonry**  
**Resulting from Rising Damp**

**FINAL REPORT**

March 2016

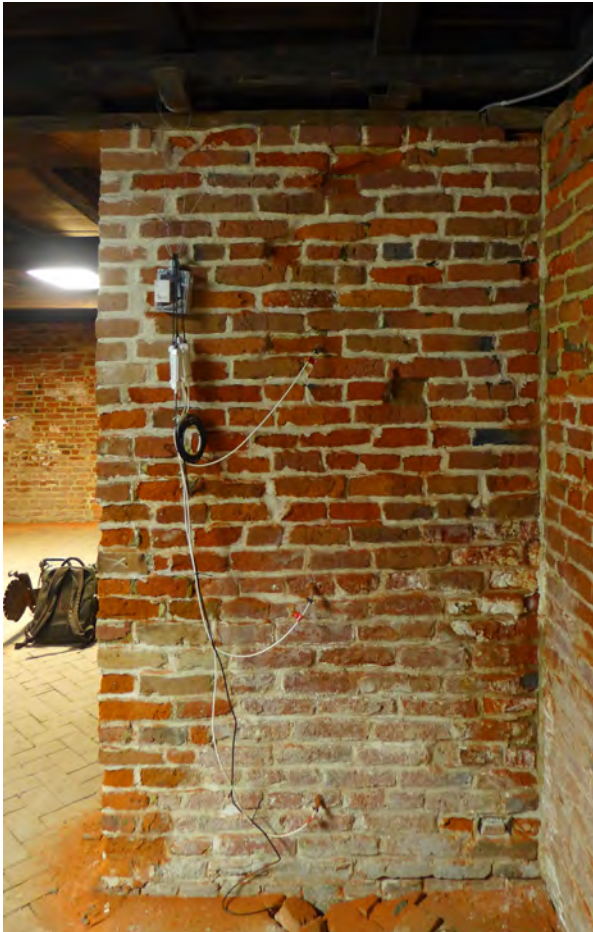
Image 3: Wall from room 281, the “poultice” side during the pilot project.

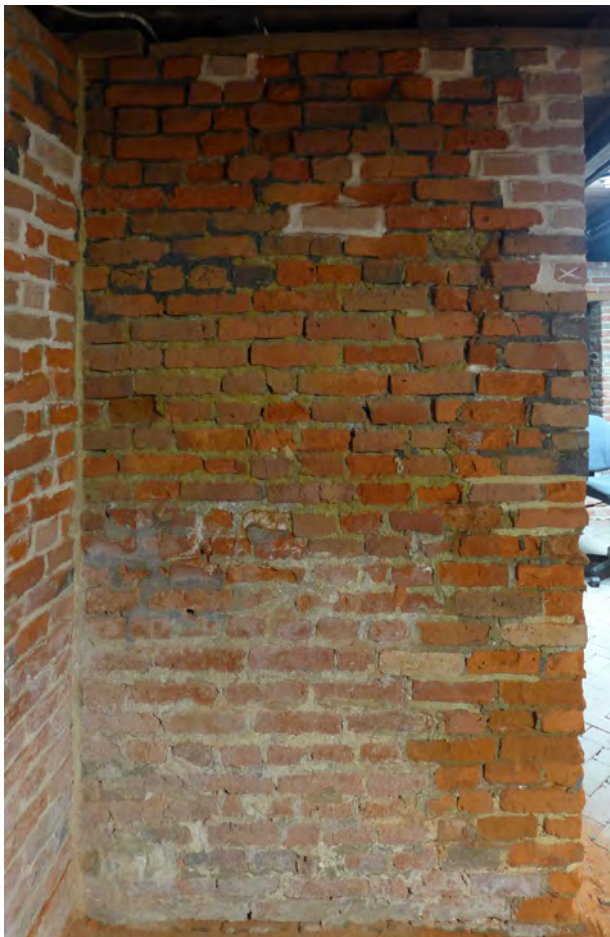
amount of brown mortar, which was relatively soft and similar in appearance to the original mortar (Appendix A, Image 4). There were also areas of spot repointing with a very hard, dark gray Portland cement-based mortar and several modern replacement bricks. The upper part of the wall end had been previously replaced with modern bricks set in the hard white mortar and the lower part of the wall end had been repointed with the dark gray mortar (Appendix A, Image 5). There was visible efflorescence at the bottom and middle of both sides of the wall and thick salt crusts on the bricks on the poultrice side. There were some areas of actively powdering bricks, particularly on the end wall.

Image 4: Wall from room 280, the “wetting” side during the pilot project.

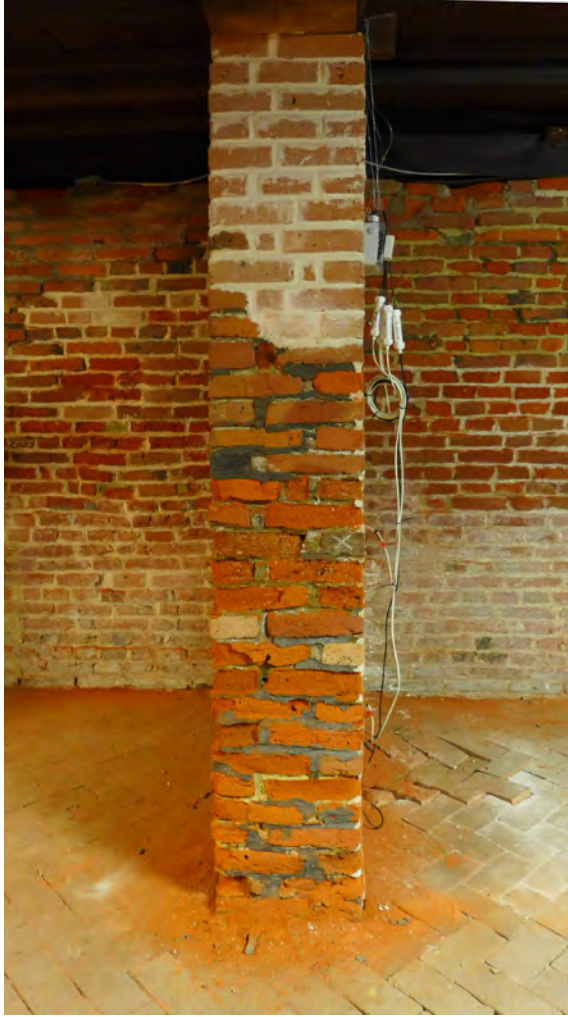
Image 5: End of test wall. The upper part of the wall had been previously rebuilt with new brick and hard mortar.

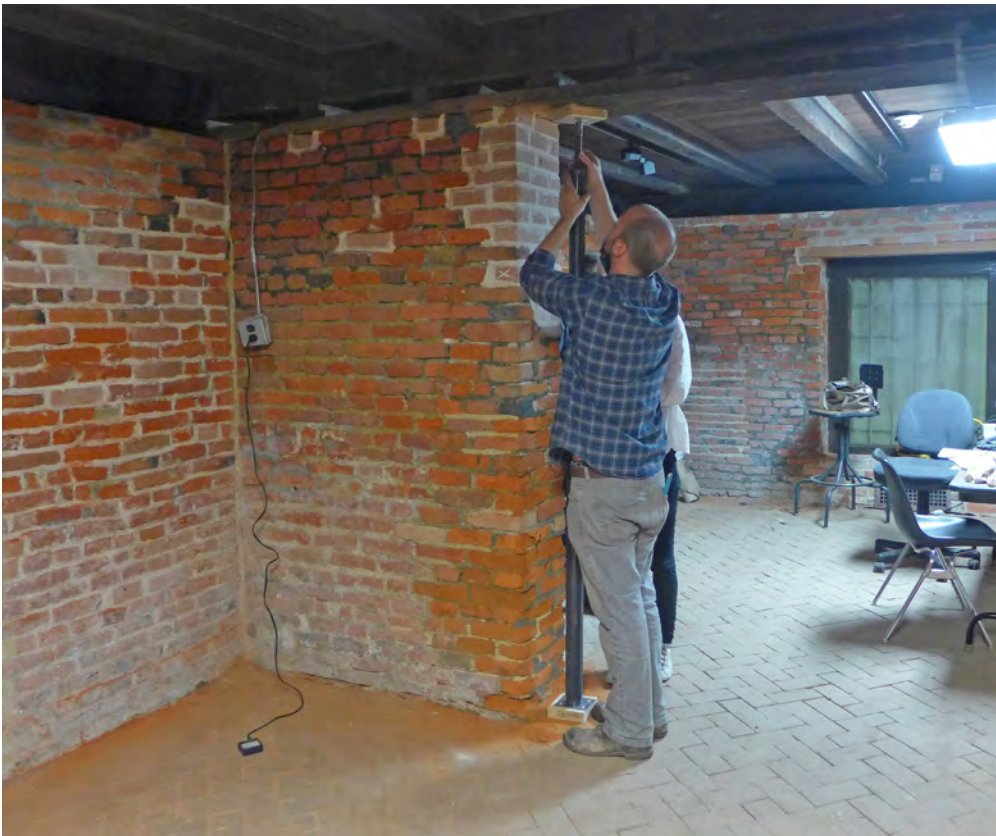
Image 6: The wood member on top of the wall was supported by a steel column before the start of the treatment.

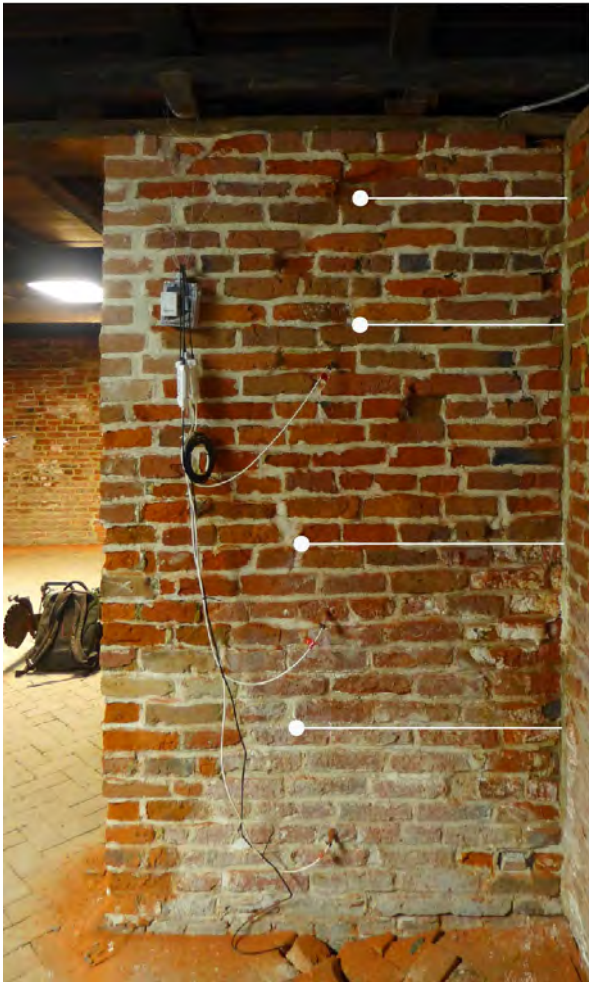
Image 7: Locations of samples removed from 281-NE4

sample 1  
(77" from floor)

sample 2  
(65" from floor)

sample 4  
(22.5" from floor)

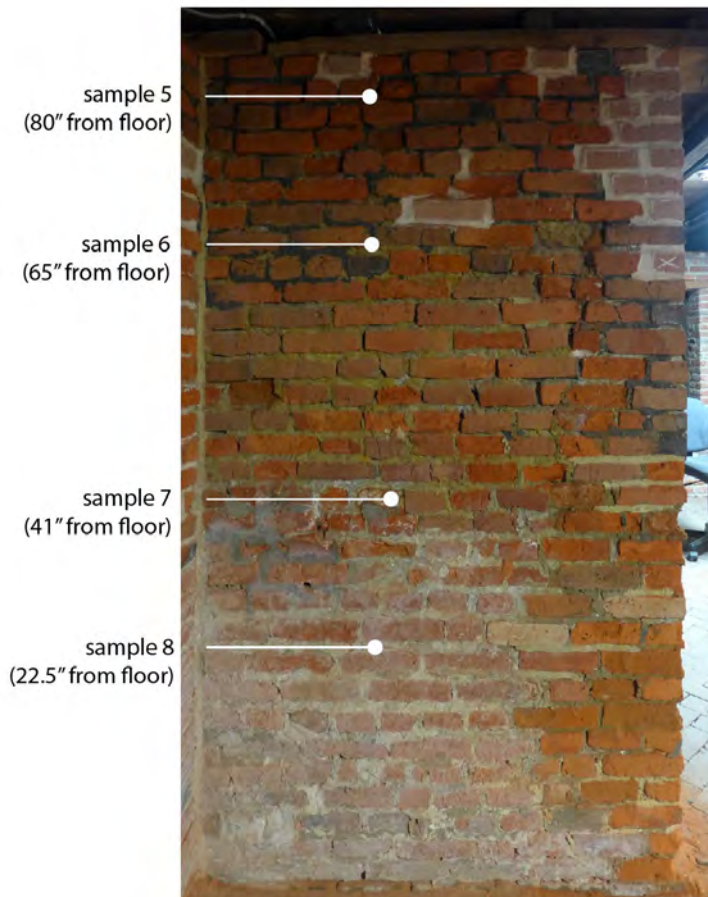
Image 8: Locations of samples removed from 280-SWI.

The highest weight percent was found in sample 6, which was removed approximately 5 feet above the floor. This location showed some visible salt, but not as much as other locations. However, the mortar surrounding sample 6 was dark gray and very hard, and was believed to be a Portland cement-based repointing mortar. The existence of this impermeable cement mortar likely raised the local concentration of salt in sample 6, which was a more permeable mortar.

sample 5  
(80" from floor)

sample 6  
(65" from floor)

sample 8  
(22.5" from floor)

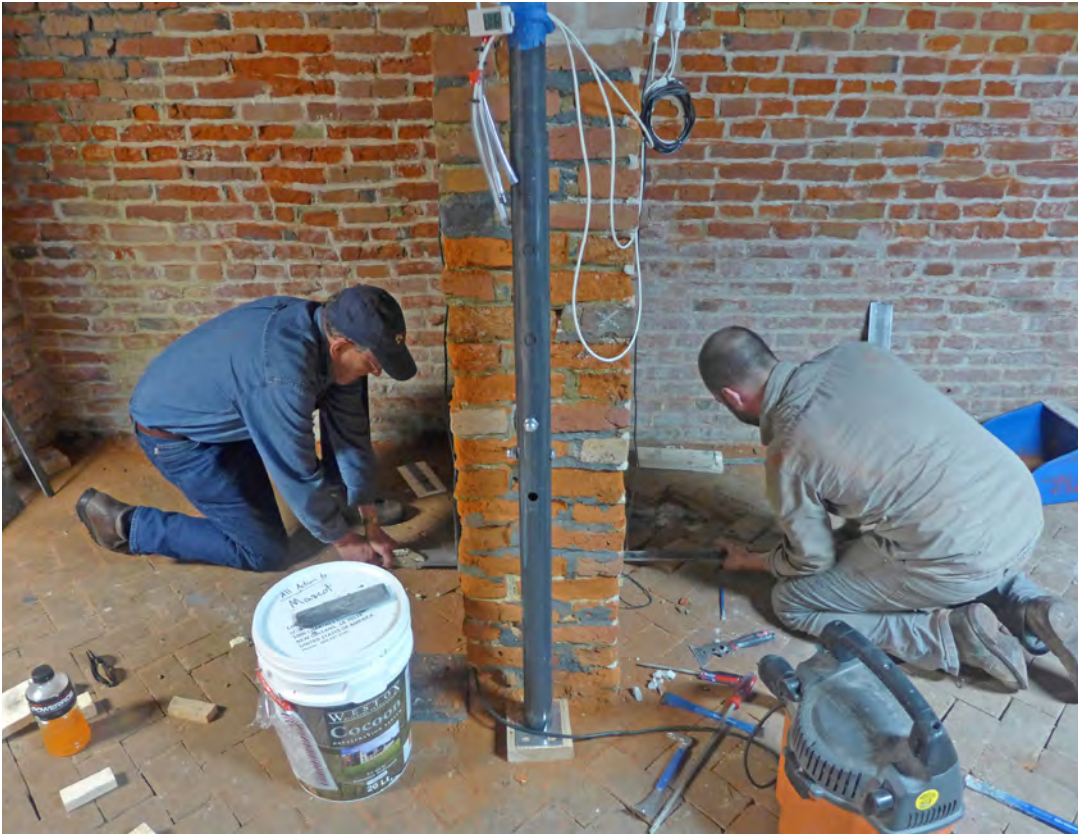
Image 9: Installing the damp proof course.

A physical barrier, slate, had been selected for the damp proof course. The slate tiles were 8.5” wide by 1’ 2” long and ¼” thick and were initially intended to be installed in a slot cut in the wall. A Husqvarna Cut-and-Break saw, capable of cutting a slot as deep as 16 inches, was chosen to cut the slot. However, this saw is gas-powered and there was concern about using it indoors. In addition, it was noted that the mortar at the ground was saturated, and it appeared likely that it would not be possible to cut a clean slot in the wall.

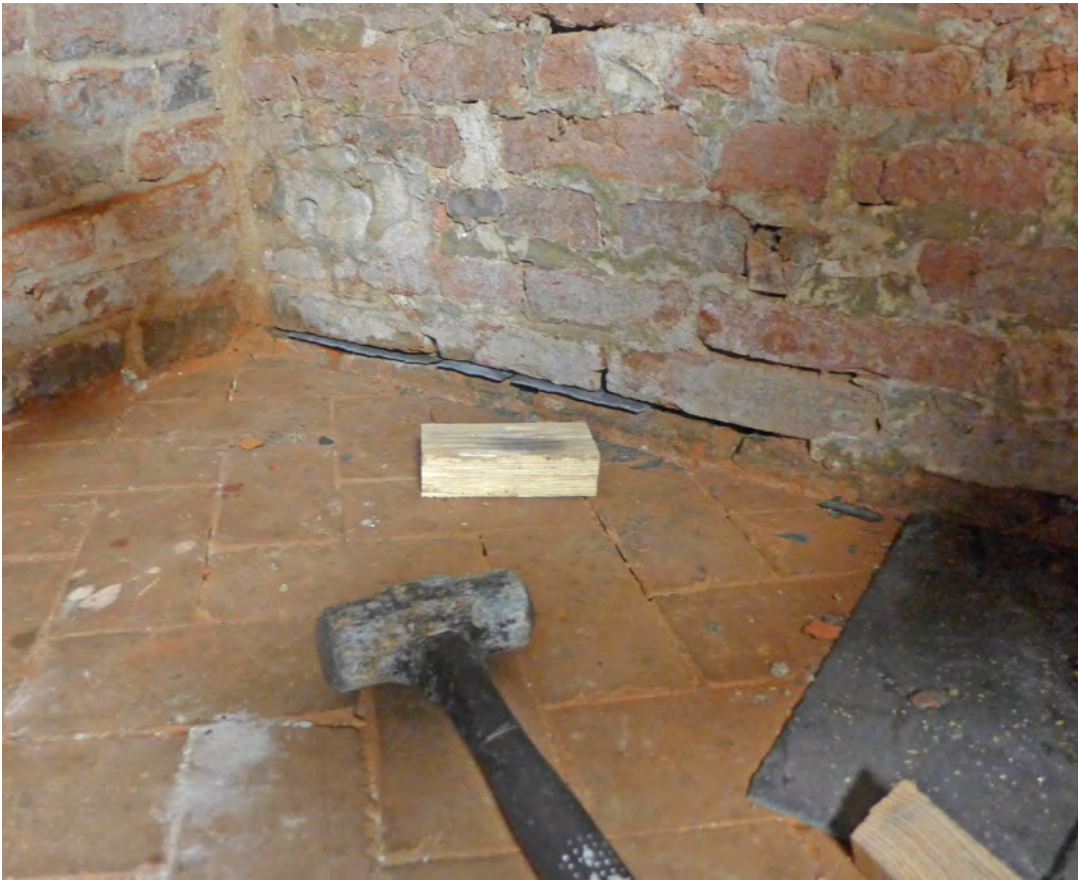
Image 10: Slate installed as a damp proof course.

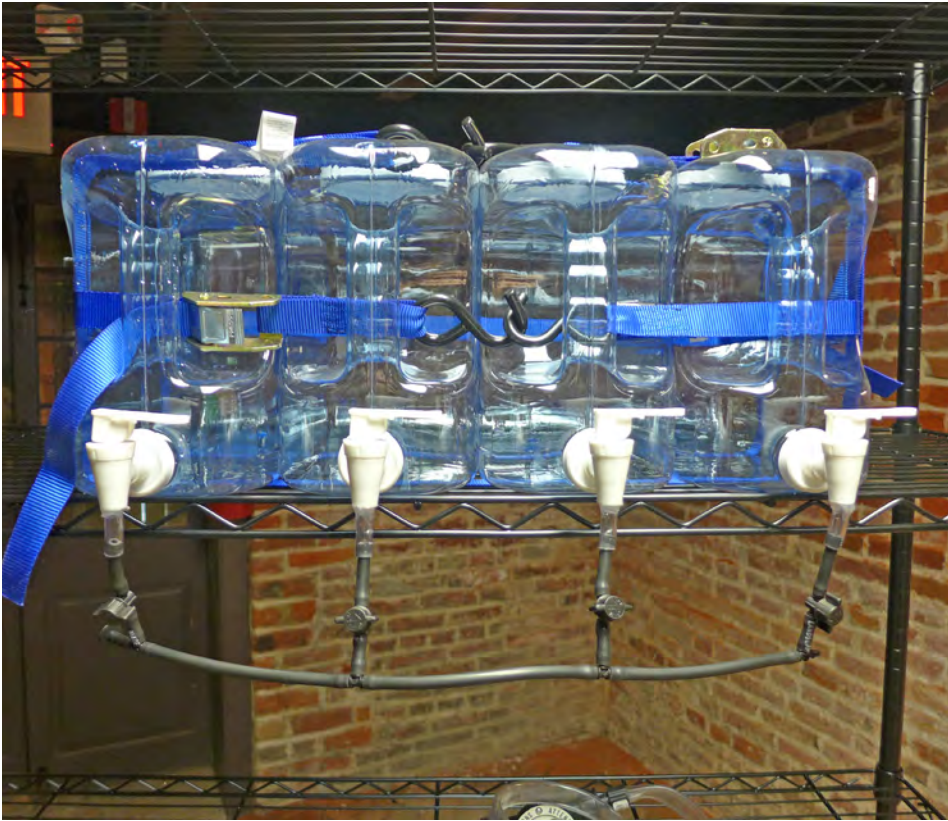
Image 11: Water dispensing units with valves installed on metal shelving adjacent to the test wall.

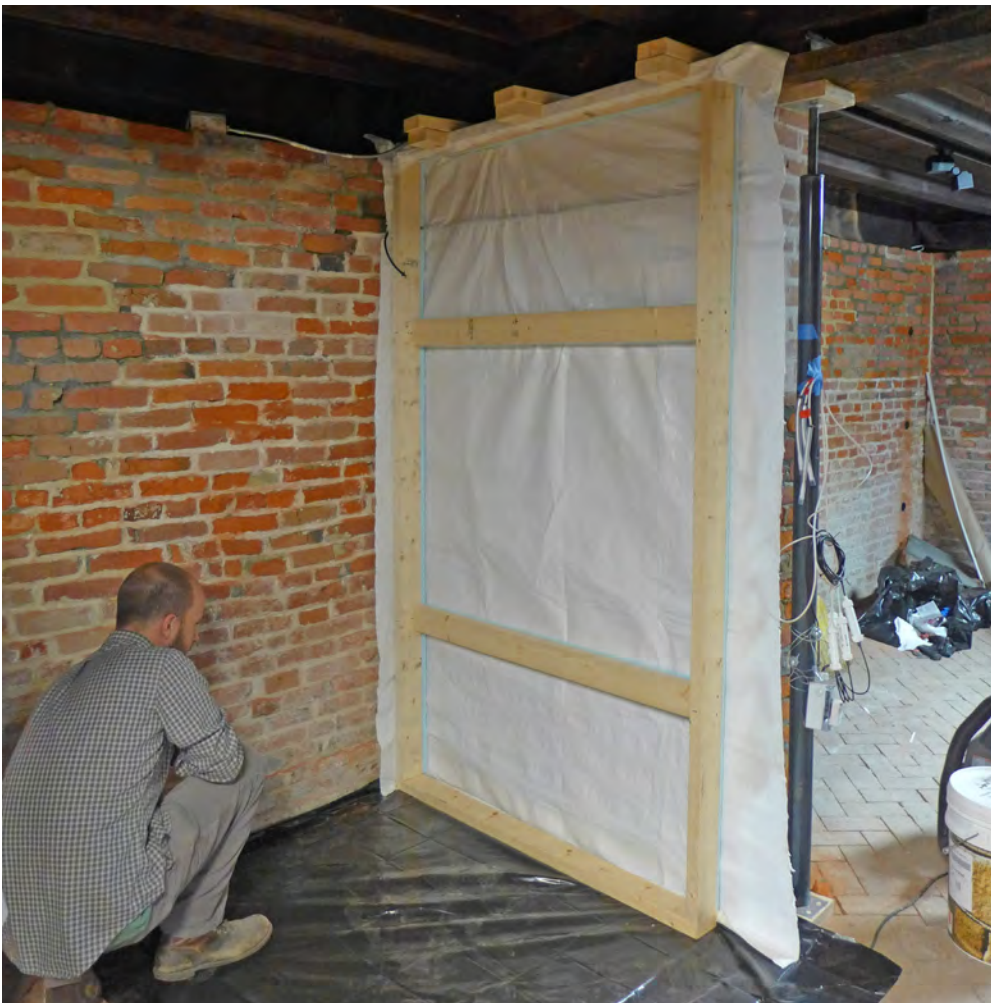
Image 12: Wet curing blanket and frame installed at wetting side of the test wall.

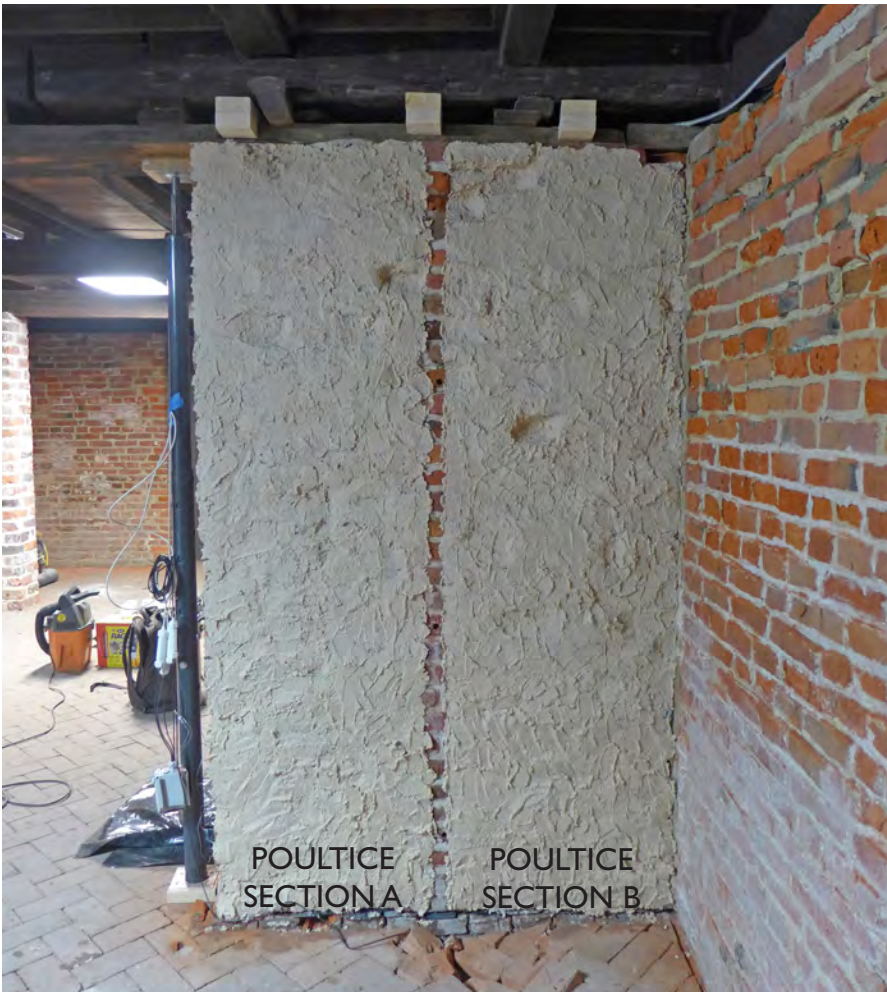
Image 13: Poultrice applied to poultrice side of wall in two sections—Section A (left) and Section B (right).

Before applying the poultice to the opposite side of the wall, the surface of the wall was vacuumed to remove crystallized salts and loose material. The poultice was then applied in two sections: Section A was 24 ½" wide, and Section B was 25 ½" wide. The two sections were separated by a 1" strip where no poultice material was applied and where the moisture monitoring meters were installed (Appendix A, Image 13).

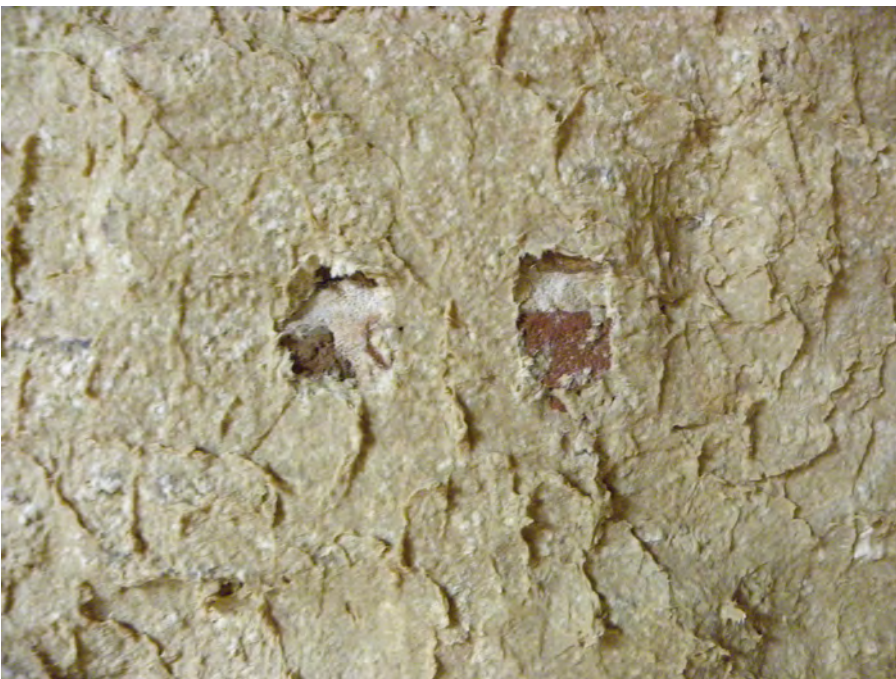
Image 14: Poultrice sampling throughout the treatment duration.

During the first two months of treatment, the site was visited every 2-5 days to observe the entire system. The irrigation system was checked each time to ensure operability. No leaking was reported and water levels in the jugs were replenished as needed. As water intake tapered off, the site was visited less frequently (every 1-2 weeks). Poultice samples were removed monthly, and Section A was removed and reapplied 3 times throughout the pilot project duration (Appendix A, Image 14). Results of the poultice sampling are discussed in section 3.0.

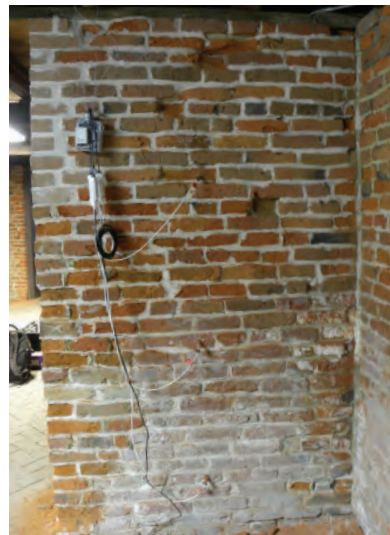
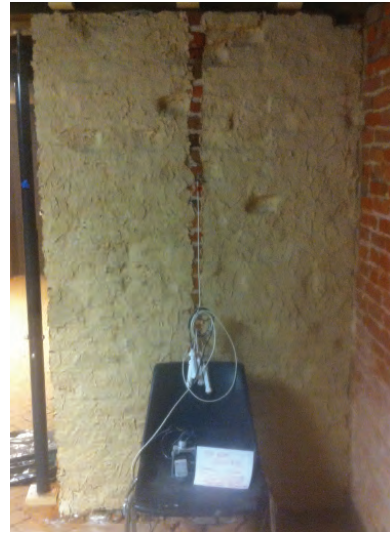
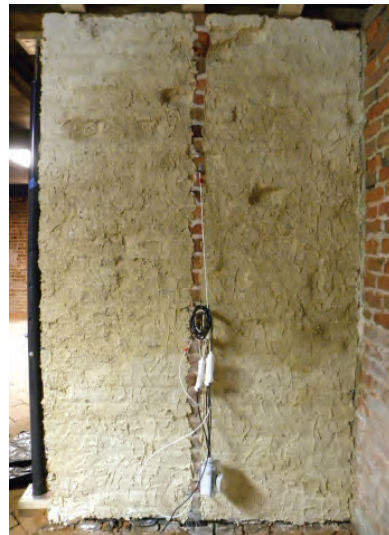
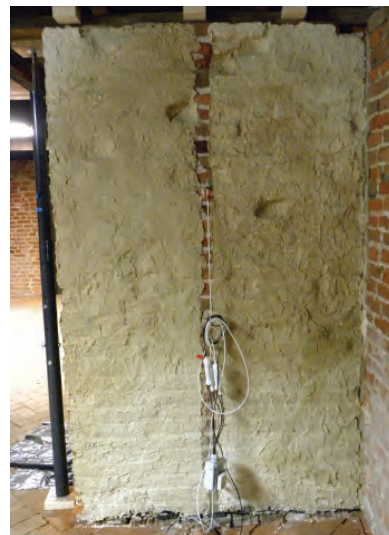
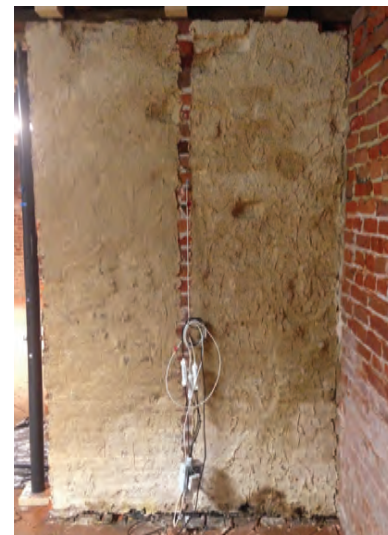
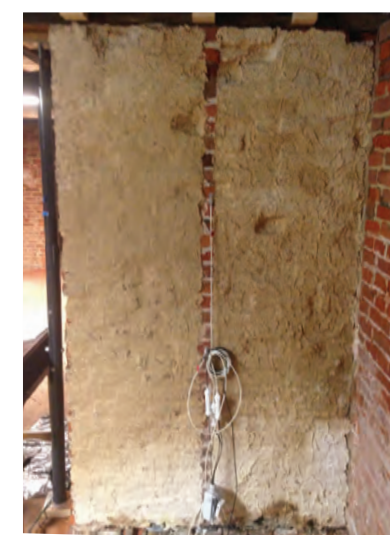
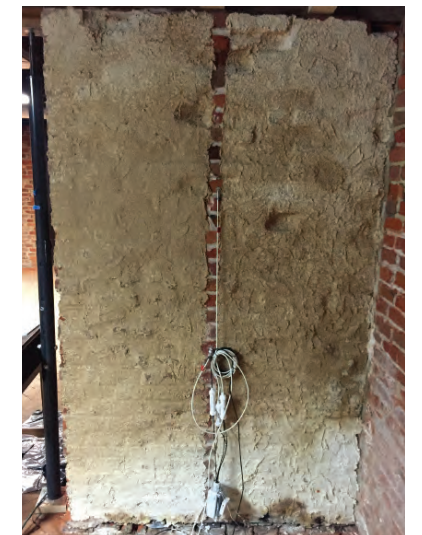
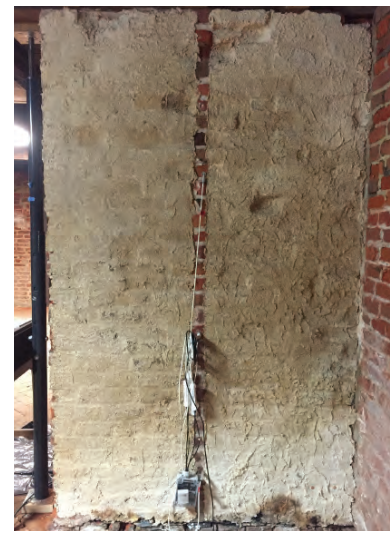
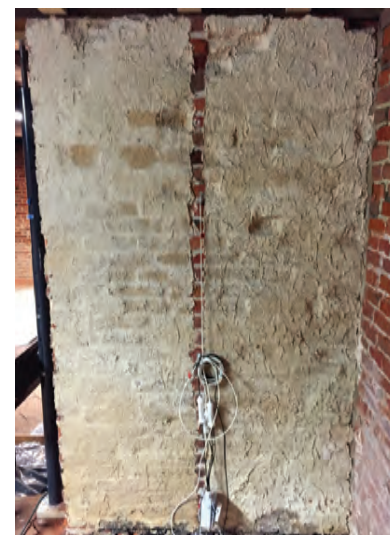
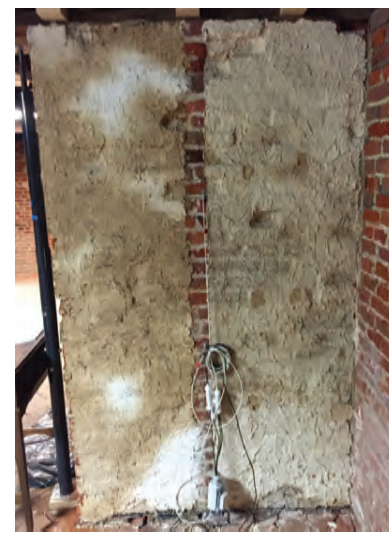
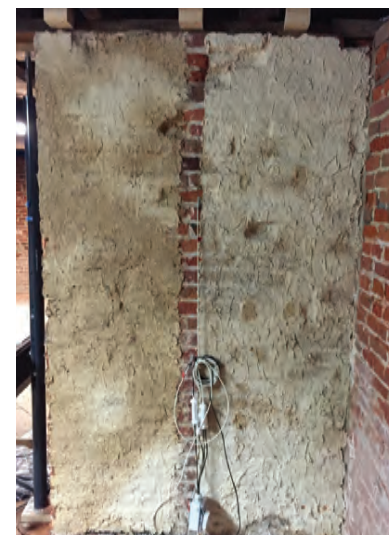
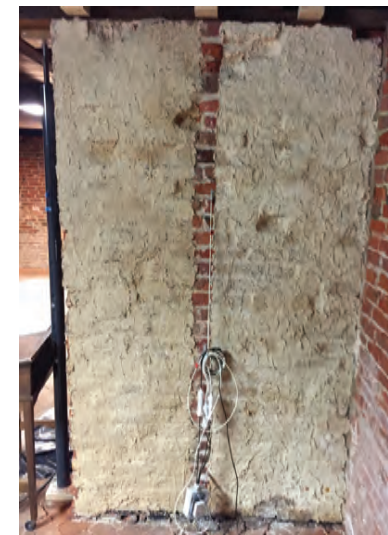
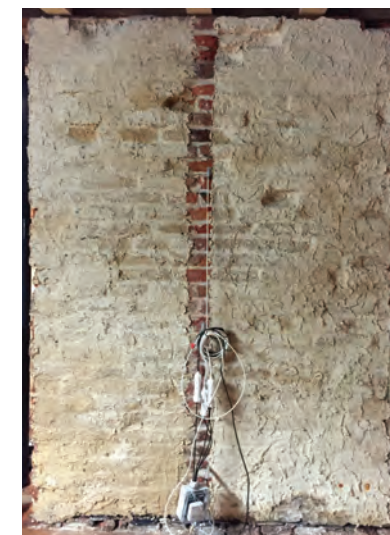
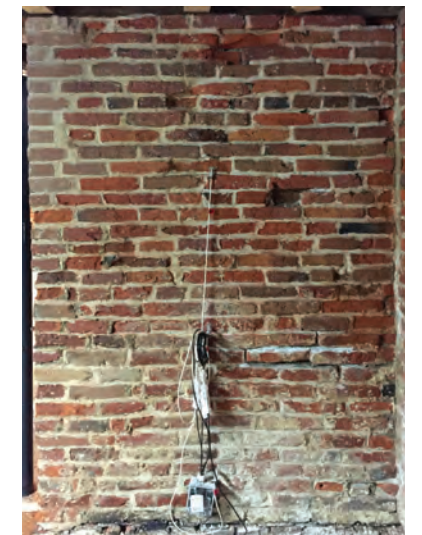
Poultice drying levels were also noted during site visits (Appendix A, Image 15). The drying patterns varied across the surface of the wall. Generally, the bottom and top of each section of poultice eventually dried, while the middle portion stayed saturated throughout the entire treatment. Seemingly random, indiscriminate dry patches were observed across the wall surface. By the end of the treatment, the poultices of both sections were still largely saturated. Drying patterns mirrored the substrate—the poultice dried over mortar joints, but stayed saturated over bricks.

Image 15: Photographs taken of wall throughout treatment duration.

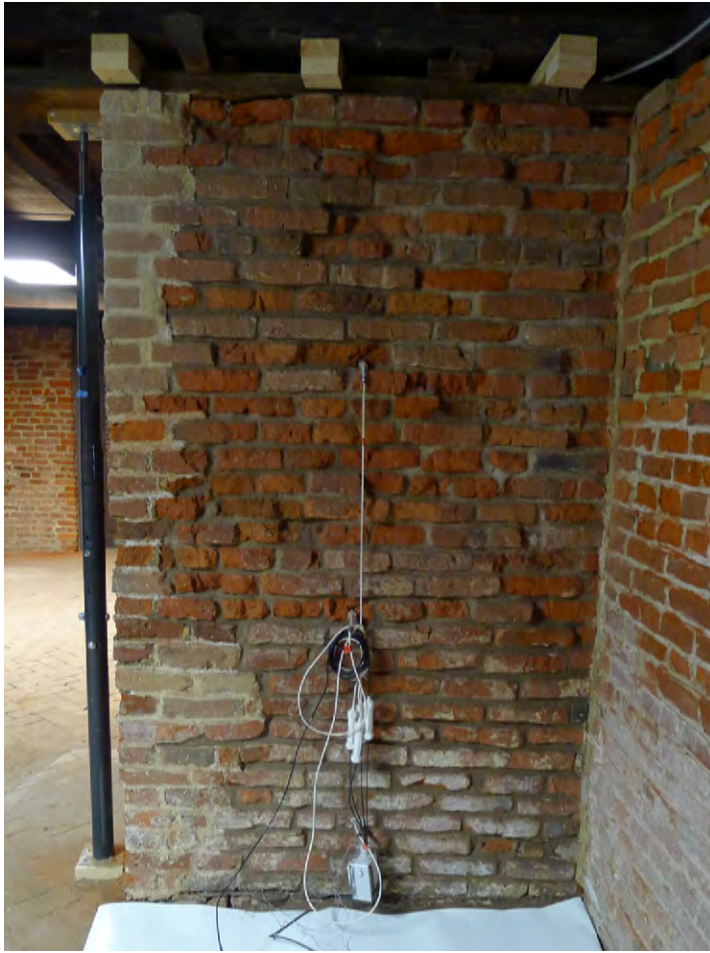
Image 16: Poultice side of wall, after repointing.

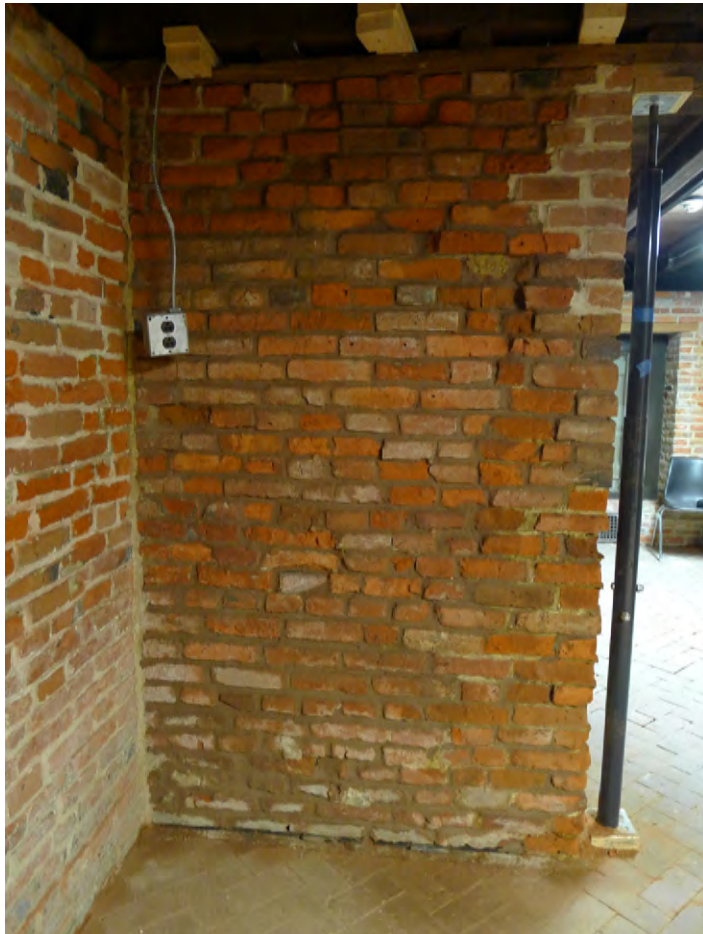
Image 17: Wetting side of wall, after repointing.
