**Madame John's Legacy**  
**Pilot Project to Develop a Treatment Protocol**  
**for Salt Damaged Brick Masonry**  
**Resulting from Rising Damp**

**FINAL REPORT**

March 2016

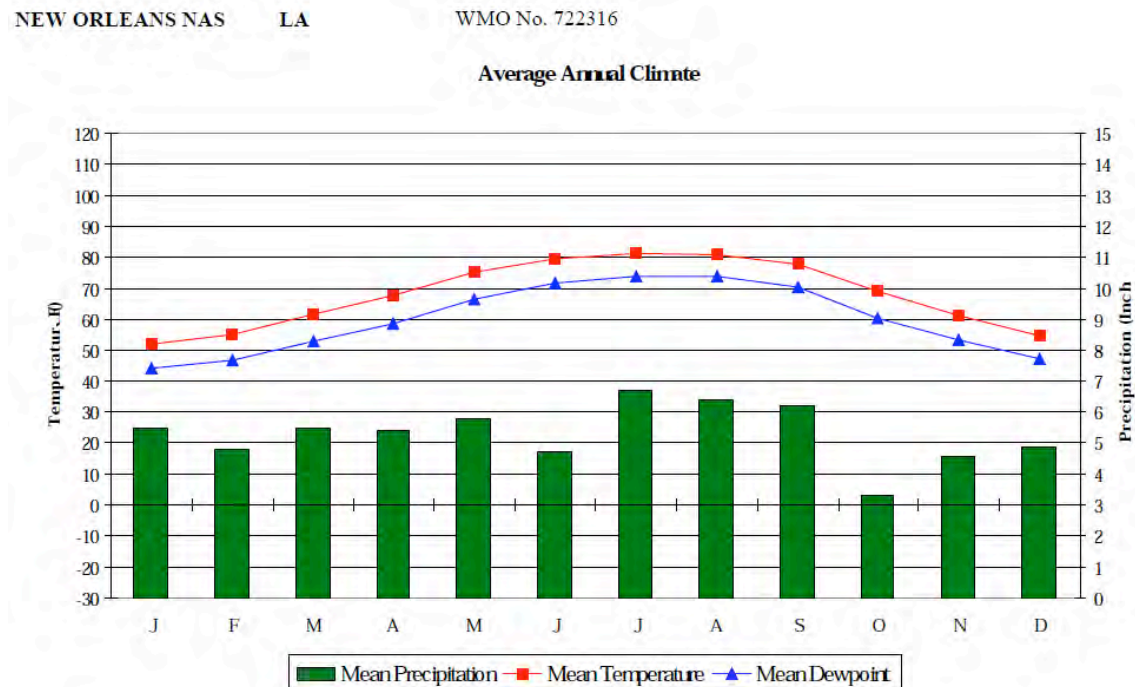
Figure 1: Average Annual Climate, New Orleans, Louisiana

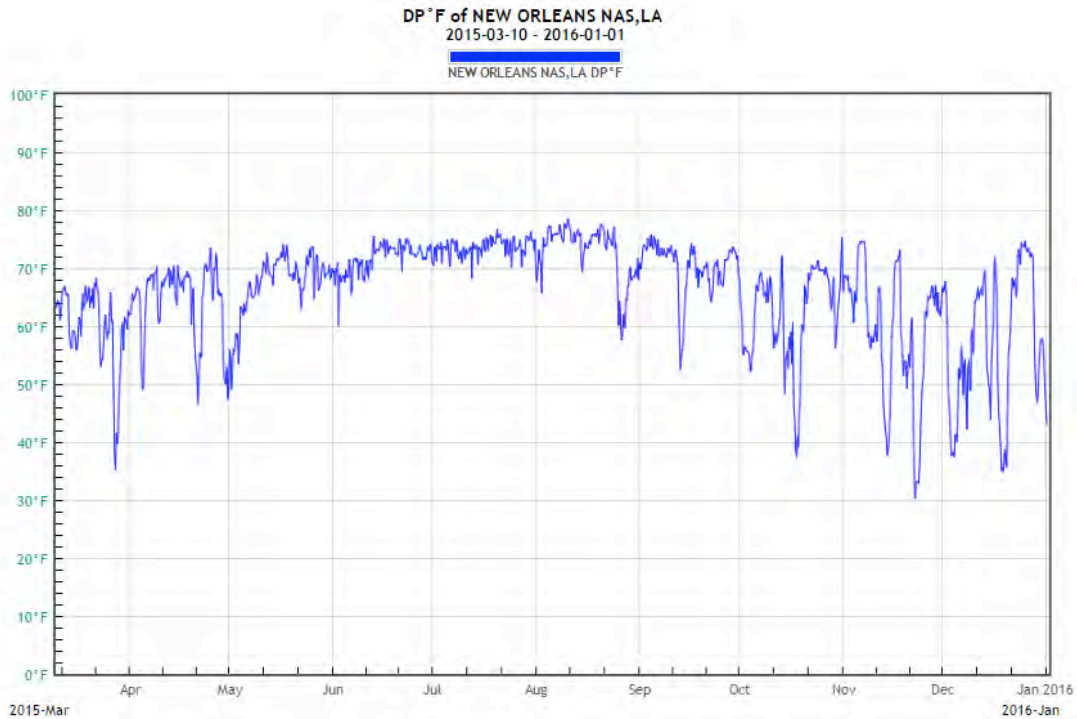
Figure 2: Dew point temperature (exterior), New Orleans, Louisiana

Comparison of the two plots in Figure 2 and 3 suggests that the ground floor is more strongly influenced by leaking conditioned air from HVAC ducts and the story above rather than by infiltration of exterior air.

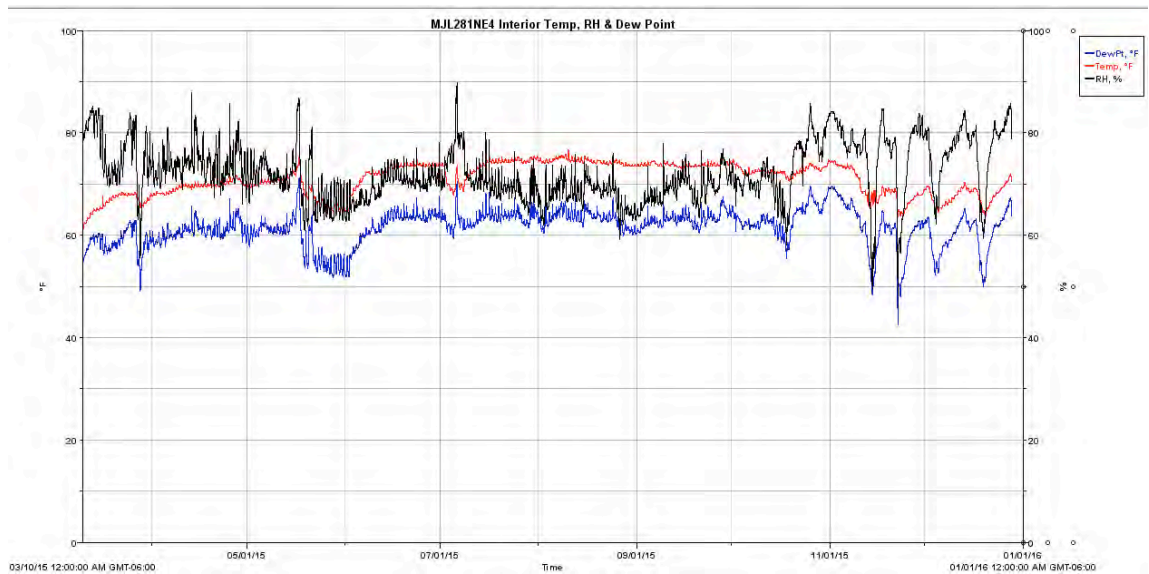
Comparison of interior and exterior dew point temperatures for the pilot project duration strongly suggests that the interior temperature and dew point conditions at the ground were influenced by HVAC systems elsewhere in the building, particularly during summer, when dehumidification is an incidental consequence of cooling. The trend plot in Figure 2, below, indicates exterior dew point temperature.<sup>2</sup> For comparison, the trend plot in Figure 3 indicates interior dry bulb and dew point temperature in the ground floor during the same period.

Figure 3: Dry bulb temperature and dew point temperature, interior of Madame John's Legacy.

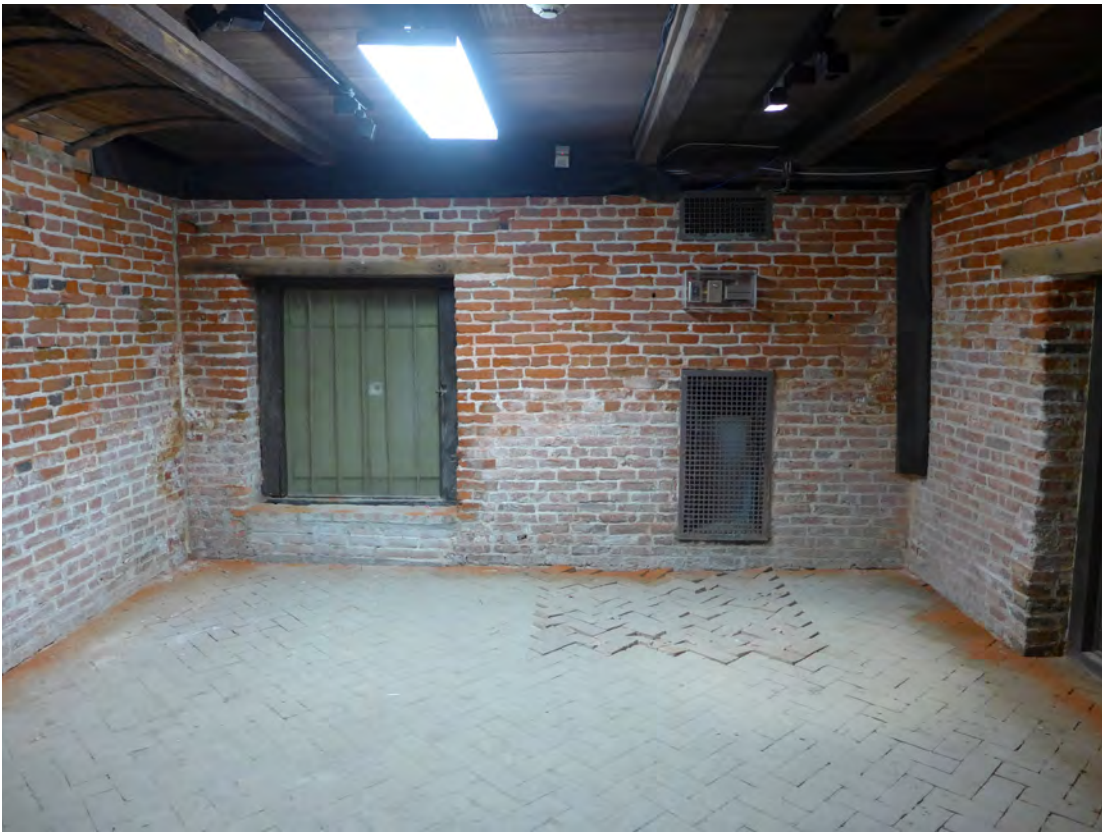
One of Louisiana's most distinguished historic structures and a National Historic Landmark, Madame John's Legacy is currently exhibiting severe brick masonry deterioration at its ground floor due to salt damage associated with rising damp (Appendix A, Image 1). The current project was undertaken to better understand the deterioration mechanisms at work and to develop a practical treatment for the deterioration. Severe deterioration of historic masonry due to absorption of salt-laden groundwater is pervasive throughout the United States, but few effective treatment options address both the reduction of rising damp and the comprehensive removal of soluble salts. This project developed such a two-pronged strategy and implemented it in a pilot project at Madame John's Legacy.

Recent research on the severely deteriorated brick masonry ground floor walls at Madame John's Legacy indicates the damage is due to salt-laden moisture being absorbed by the walls from the ground. The brick walls are in direct contact with soil, which contains both nitrate and chloride salts. The uninterrupted absorption of moisture from the soil over many decades has resulted in the accumulation of extremely high concentrations of salt in the brick throughout the depth of the walls. The high permeability of the historic brick and the original lime-stabilized, earthen mortars facilitates the rising damp. Subsequent incompatible repair materials—including high-fired brick and impermeable Portland cement-based mortars, as well as the installation of a concrete sub-pavement with moisture barrier—have exacerbated the problem. In addition, the environmental conditions within the building are conducive to deterioration as the salts move in and out of solution due to the fluctuating relative humidity.

Deterioration of the masonry is ongoing and very visible to anyone entering the ground floor of Madame John's Legacy. Salts and moisture continue to wick up into the walls and the hygroscopic salts in the wall hold and absorb moisture from the air. Therefore, the problem is both salts and moisture, and both work together during the hydration/drying processes to cause deterioration. It is important that any future treatment addresses the sources of both problems. An ideal remedy to prevent future deterioration would involve the elimination of both factors simultaneously.

Image 1: Ground floor of Madame John's Legacy.

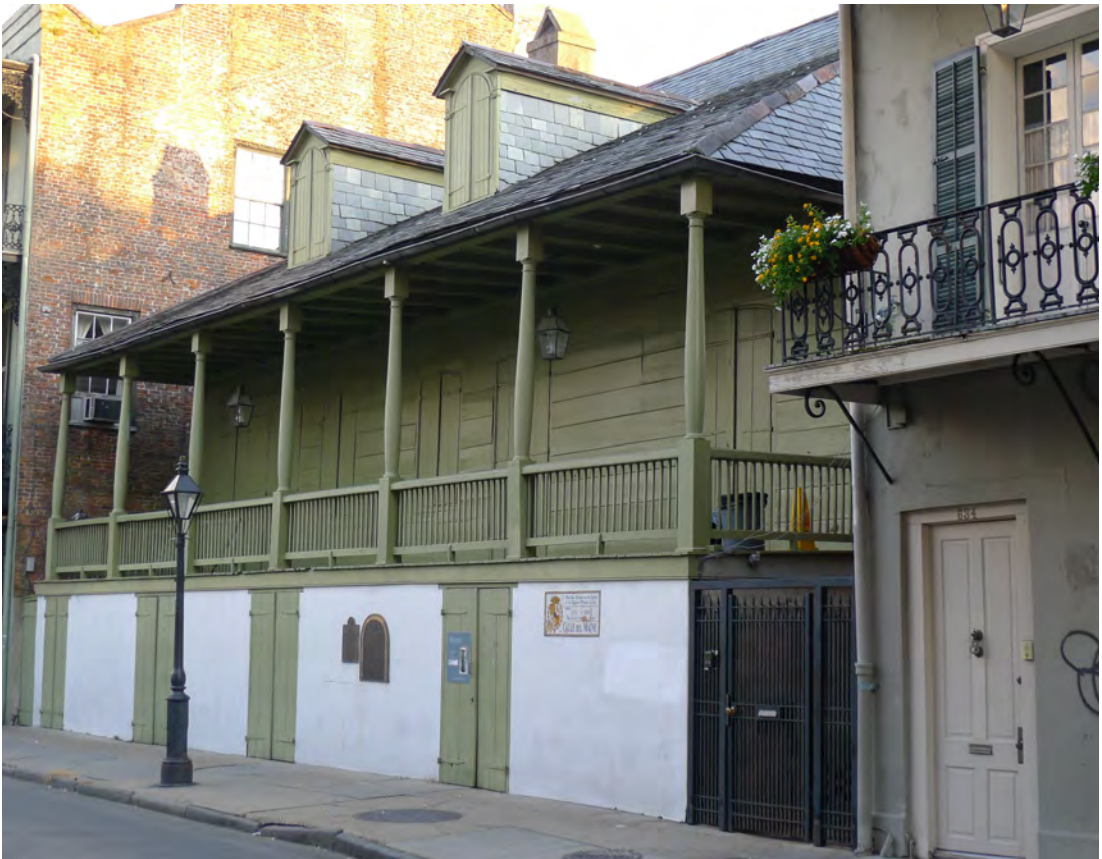
houses dating to the early- and mid-19th century. Madame John's Legacy features a raised brick basement flush with the sidewalk and a deep front porch running lengthwise with the street (Appendix A, Image 2). Its second floor is composed of wood framing and "brick between post" construction. It also has a large, hipped roof with two small dormers. It is more reminiscent of the 18th century French-Creole plantations that dot the rural levees of the Mississippi River outside of town, than of the typical urban dwellings in the French Quarter.

Image 2: Madame John's Legacy, elevation facing Dumaine Street.
